Navajo Abandoned Uranium Mine

Site Screen Report

Mesa II ¼ Mine AUM Site

Weston Solutions, Inc.

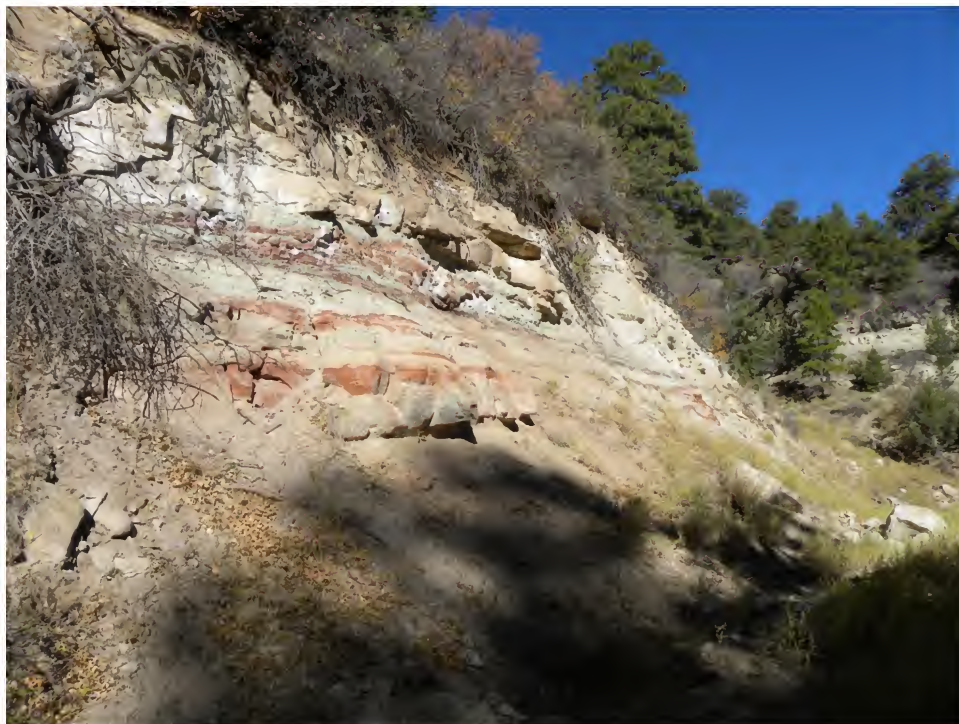
Photo 4. Mine site waste pile

Waste debris from rock face at north side of site (30' h x 75' w) extends northeast into drainage area, with a total estimated volume of 417 yd³

Unreclaimed waste pile
